**DEPARTMENT OF TRANSPORTATION****DIVISION OF ENGINEERING SERVICES**

Contract #: 04-0120F4Cty: SF/ALA Rte: 80 PM: 13.2/13.9File #: 1.28**WELDING INSPECTION REPORT****Resident Engineer:** Casey, William**Address:** 333 Burma Road**City:** Oakland, CA 94607**Report No:** WIR-027442**Date Inspected:** 12-Apr-2012**Project Name:** SAS Superstructure**OSM Arrival Time:** 700**Prime Contractor:** American Bridge/Fluor Enterprises, a JV**OSM Departure Time:** 1530**Contractor:** American Bridge/Fluor Enterprises, a JV**Location:** Job Site**CWI Name:** Salvador Merino**CWI Present:** Yes No**Inspected CWI report:** Yes No N/A**Rod Oven in Use:** Yes No N/A**Electrode to specification:** Yes No N/A**Weld Procedures Followed:** Yes No N/A**Qualified Welders:** Yes No N/A**Verified Joint Fit-up:** Yes No N/A**Approved Drawings:** Yes No N/A**Approved WPS:** Yes No N/A**Delayed / Cancelled:** Yes No N/A**Bridge No:** 34-0006**Component:** OBG Components**Summary of Items Observed:**

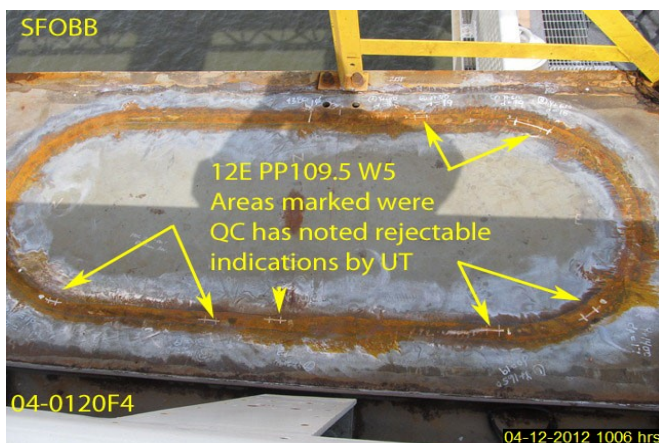
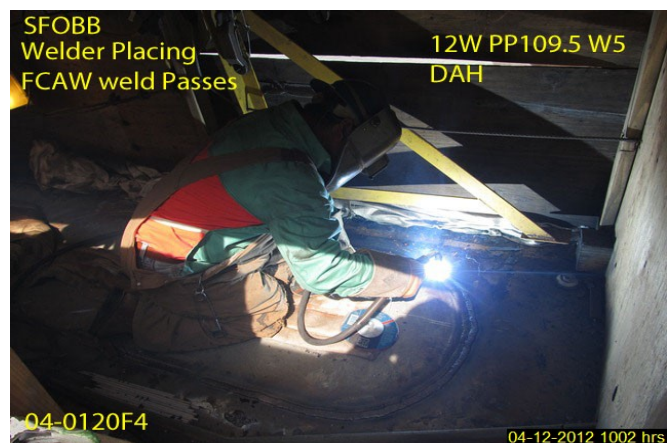
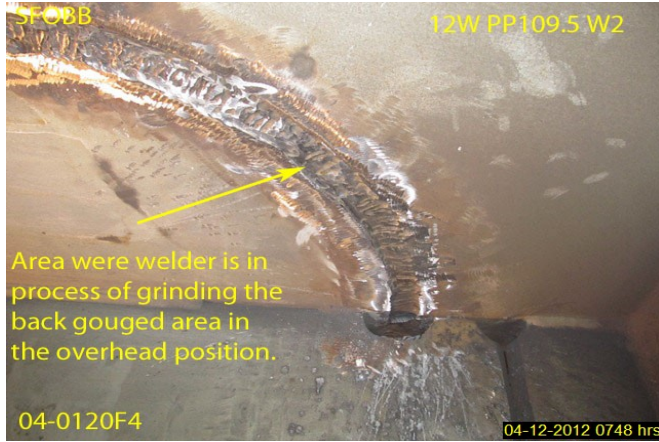
This QAI observed welder Salvador Sandoval placing the Flux Cored Arc Welding (FCAW) process for the intermediate weld passes with the E71T-1M, 1.6mm electrode. The pre-heat for this location was measured at 65 degrees C (150 degrees F) using a weed burner which were verified using a tempstik and infrared gun by the QC. The welder was also observed by this QAI as using a chipping hammer, power grinder and power wire wheel for the interpass cleaning. The WPS for the Complete Joint Penetration was WPS-D1.5-3040A-1 with welding parameters measured at 270 amps, 25.2 volts. The area for welding was then pre-heated prior to welding at 40 degrees Celsius (150 degrees F) which was verified using a tempstik and infrared gun by the QC. The welder began placing the intermediate weld passes for this location and using a power grinder and power wire wheel for the interpass cleaning. The QC inspector for this location was Salvador Merino and was observed verifying and documenting the welding parameters for this location, along with overseeing the welding operations. At the time of the observations no issues were noted by the QAI.

This QAI observed that welder Khit Lounechaney was using a power grinder at 12W PP109.5 W5 (interior) where the welder had perform the back gouge for the deck access hole that was performed yesterday. The welder was observed in the overhead grinding this area. At the end of this QA inspectors shift the welder was still in process

This QAI observed that welder Damien Llanos with J.W. Spencer Mechanical was using the Shielded Metal Arc Welding (SMAW) process, with E6010 1/8" electrode for the root pass and E7018 3/32" electrode. The Welding Procedure Specification (WPS) used for this location was 1-12-1 with a measured welding parameter of 93 amps. The welder was also observed by this QAI as using a chipping hammer, power grinder and power wire wheel for the interpass cleaning. The location of the welding was on the East bound lane for the 65mm domestic water line and 100mm compressed air line. The areas were being welded were the butt joints for the water and air lines located behind the barrier rails at the following locations.
